**LiteTouch Er:YAG laser Preparation of Class VI
Restorations Lower Incisors**

Academy of Laser Dentistry

Advanced Proficiency Clinical Case Studies

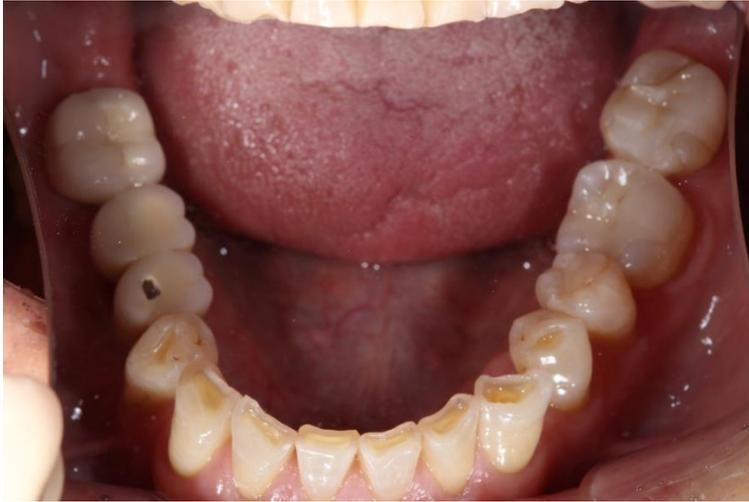
61-year-old male patient. The patient was concerned with the overall appearance of his discolored incisal edges, and the rough sensation to his tongue (Figure 1) .

Figure 1: Preoperative view

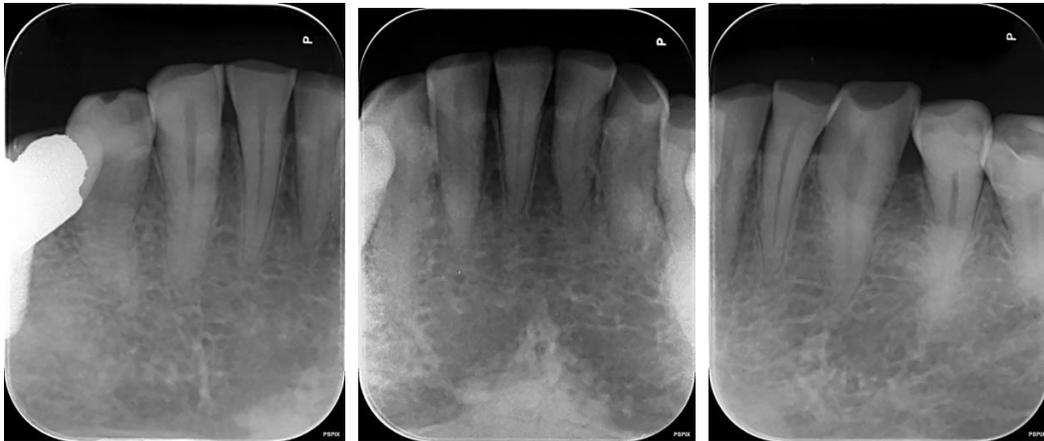
Periapical radiographs showed no signs of bony lesions. Bone density was within normal limits and moderate attrition was visible radiographically.

Figure 3: Preoperative radiographs

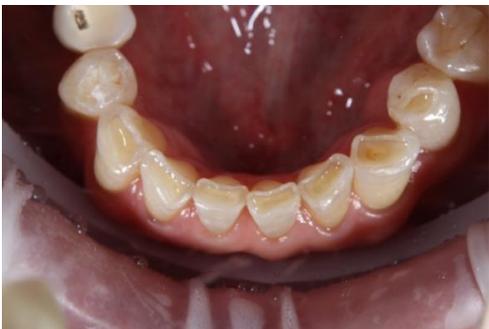
Remaining lower dentition was intact with no signs of mobility or decay. Lower dentition from Premolar to Premolar (#21 through #28) showed signs of moderate attrition with incisal wear exposing dentin and felt rough to the patient's tongue. These rough incisal edges were stained (dentin). All teeth present in lower arch were vital relative to thermal assessment, percussion, and healthy apices on periapical films.

Figure 4: Preoperative view

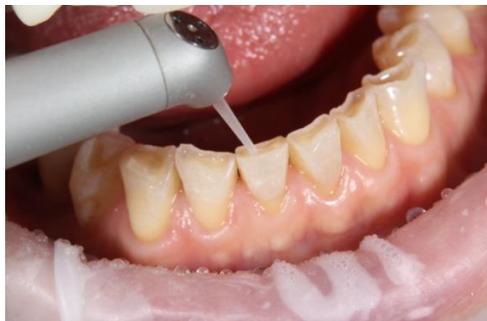
Figure 5: Er:YAG laser procedure underway

An Er:YAG laser (Lite Touch, Light Instruments LTD, Israel) 2940 nm, 800 micron sapphire tip in non-contact mode with water, and with control panel settings of 200 mJ and 30 Hz for 10 minutes in total to remove the stain, decay and smear layer on the dentin while etching the enamel surfaces for improved retention.

- The Er:YAG laser was used with water to prepare the teeth, with special attention paid to avoiding higher energy settings which would risk the involvement of pulpal exposure or sensitivity.
- A slight “paint brushing” motion was used as the preparations proceeded without discomfort from right (tooth #28) to left (tooth #21). The removal of stain, decay and fractures was rapid and the final result was obtained very quickly.
- 37% phosphoric acid was used for 30 seconds in a total etch manner to etch the enamel and dentin surfaces and a bonding agent (Scotchbond Universal 3M ESPE) was brushed onto the prepared surfaces. LED Ultracapacitor Curing Light system (Demi Ultra , Kerr) was used to cure the bond in 5-second increments per tooth.
- Flowable composite resin (MI LOW Flow A3, GC) was placed into the incisal edges and again cured for 5 seconds with Curing Light system.

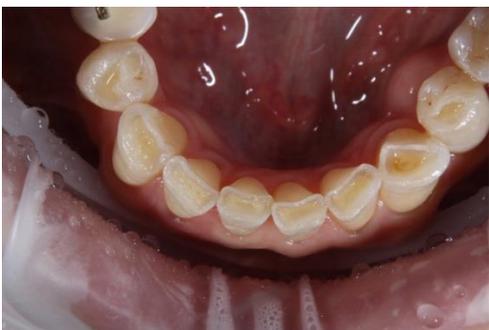
Figure 6: Immediate postoperative view of Er:YAG cavity preparation

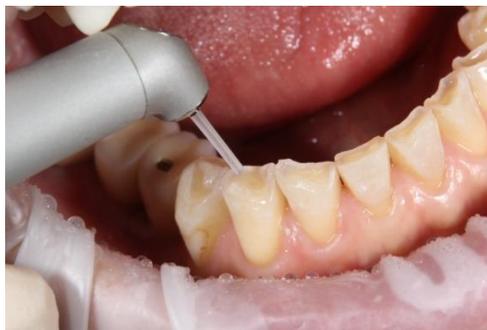
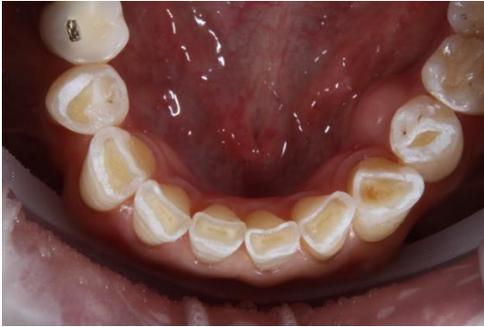
Figure 7: View just prior to bonding

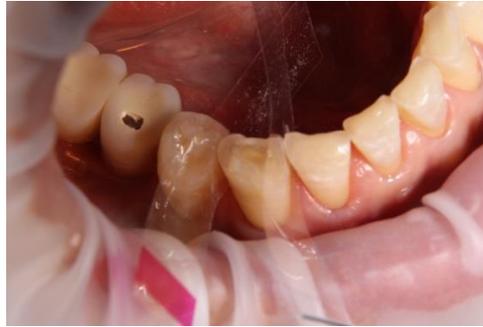
Figure 8: Cavity isolation

- The teeth were isolated with cotton rolls as it was felt that adequate isolation was possible without rubber dam placement.

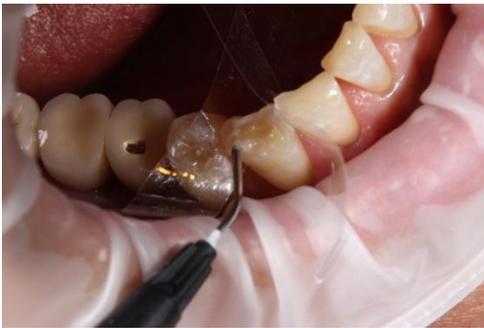
Figure 9: Composite filling

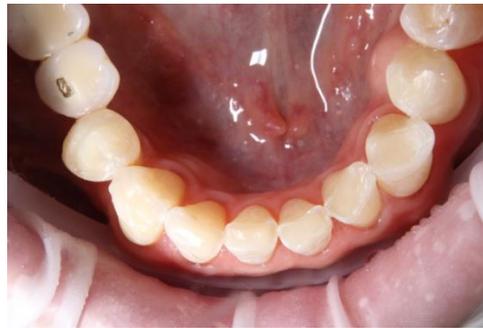
Figure 10: Restorations in place

Shaping and polishing was accomplished with diamonds and 12- and 30- bladed composite resin burs, and the interproximal areas were cleaned with Brassler diamond strips. Enhance polishing cups with PrismaGloss polishing paste were used to complete the restorative phase.

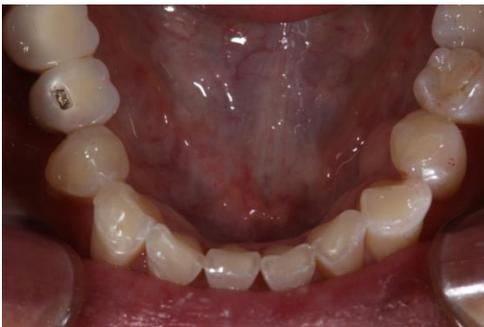
Figure 11: Immediate postoperative view

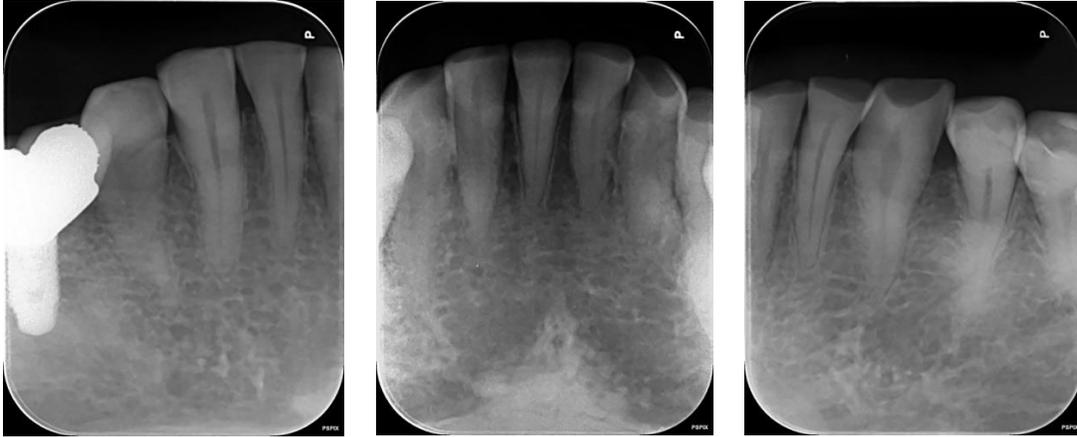
Figure 13: three-month postoperative radiographs

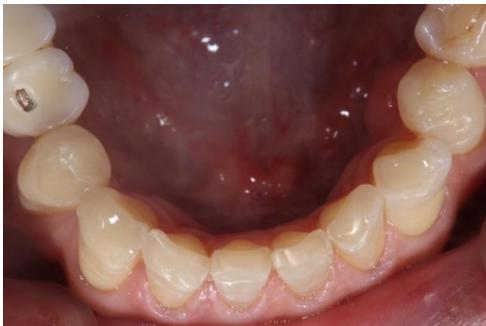
Figure 14: One-month postoperative view

The patient returned for a 1-week postoperative evaluation and the restorations looked fine. He mentioned that it did take him a little longer to get used to the new feel of the incisal edges of the restorations but that in the last couple of days he was not noticing them anymore. The patient returned for a 1-month post- operative evaluation. All teeth maintained their vitality and are extremely comfortable to function as of the 1-month healing time.

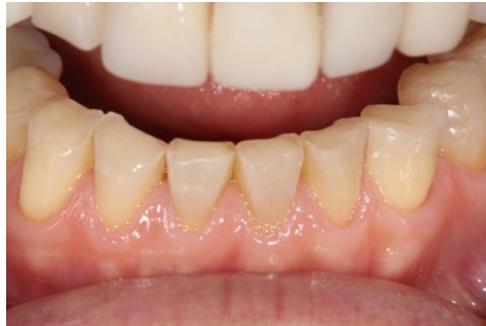
Figure 15: One-month postoperative view

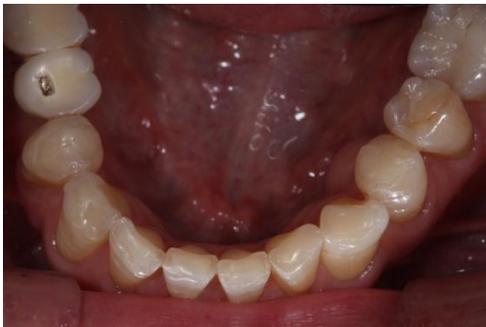
Figure 16: Three-month postoperative view

As of nearly 3 months postoperatively, the restorations are intact and appear to be lasting well. The long-term photographs taken 6 months postoperatively show excellent, stable results with no further attrition or loss of the restorations

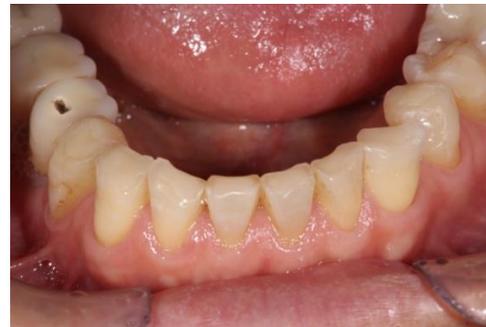
Figure 17 Three-month postoperative view

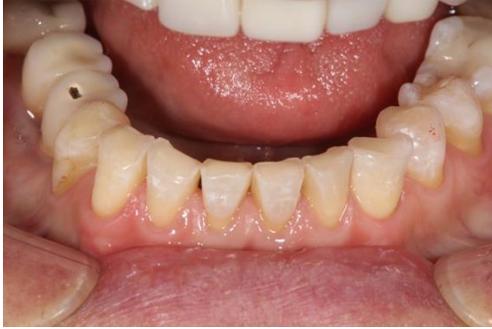
Figure18: Six-month postoperative view

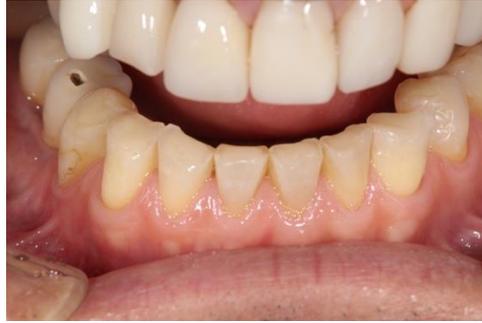
Figure19: Six-month postoperative view
